# **Mackenzie Valley Highway Project Technical Data Report—Fish and Fish Habitat**

**Government of the Northwest Territories**

**K'alo-Stantec Limited**

December 2022

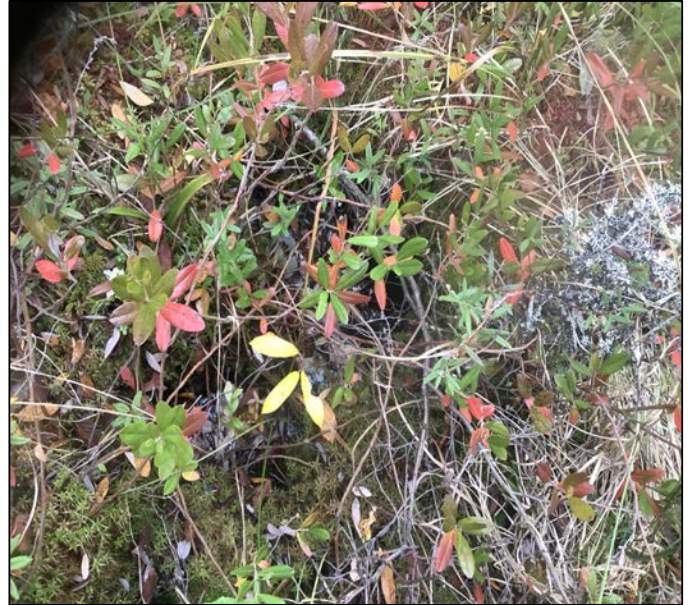
Photo 2. Subsurface flows to east of existing winter road

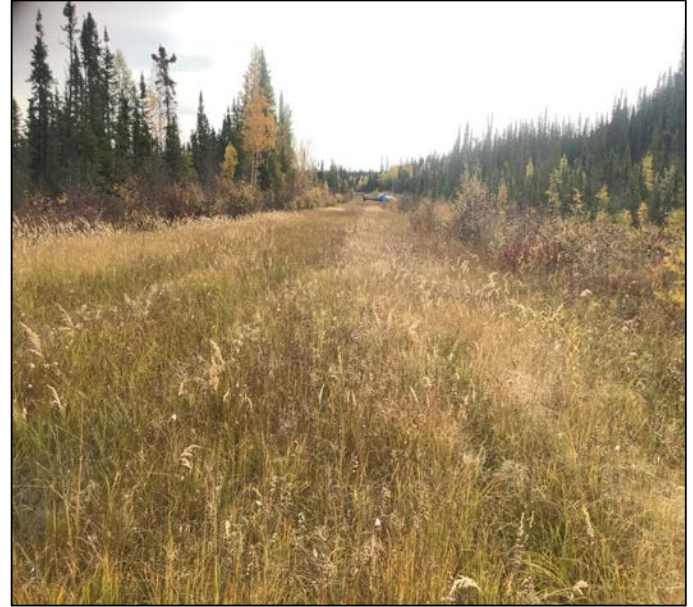
Photo 2. Facing south down existing winter road, no visible outlet

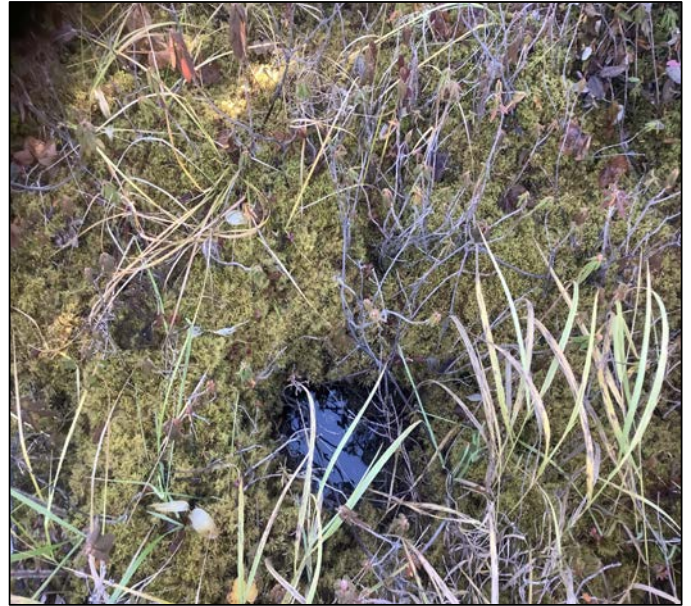
Photo 2. No channelization 40 m east of existing winter road

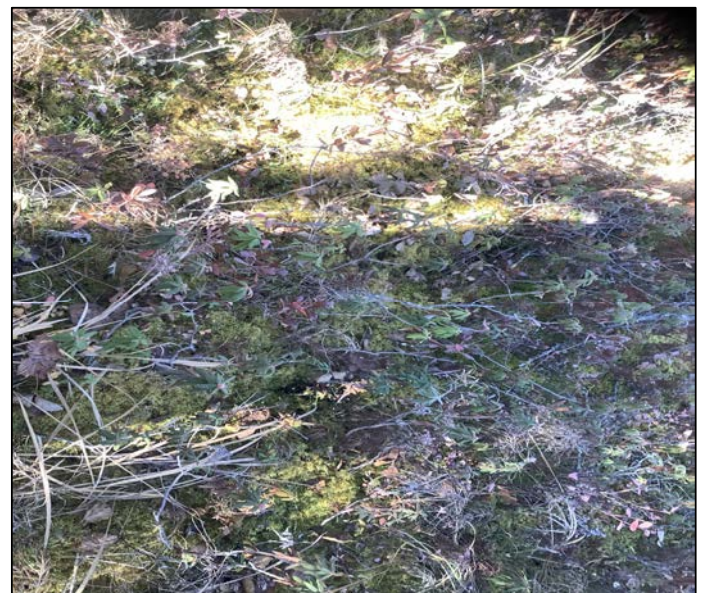
Photo 4. No channelization 50 m east of existing winter road

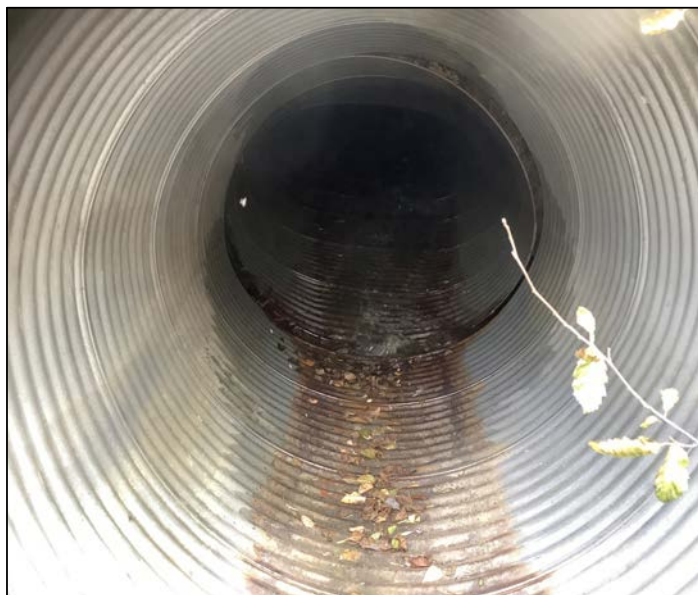
Photo 3. Facing upstream showing damaged culvert

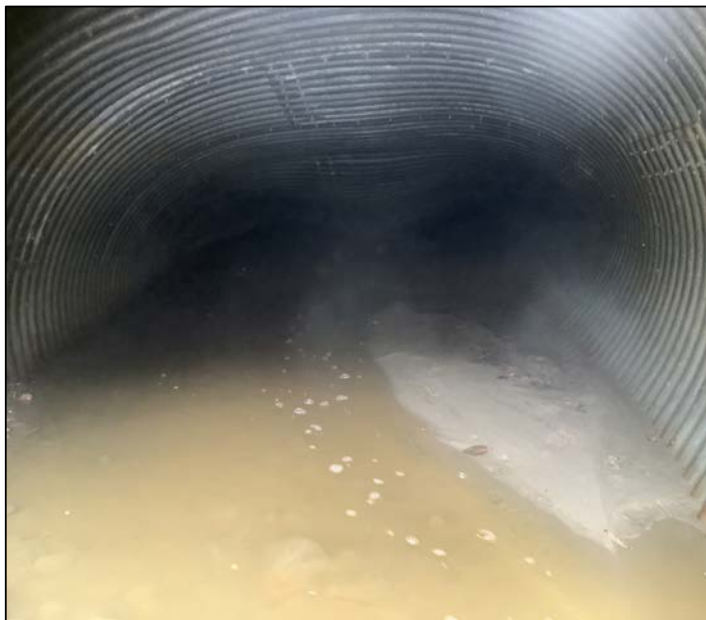
Photo 1. Facing outlet, culvert collapsed in centre

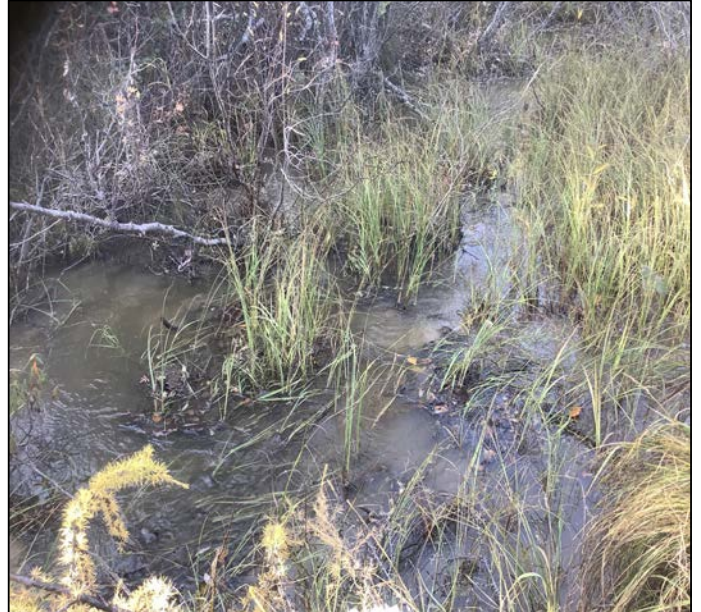
Photo 2. No defined bed or banks 35 m west of winter road

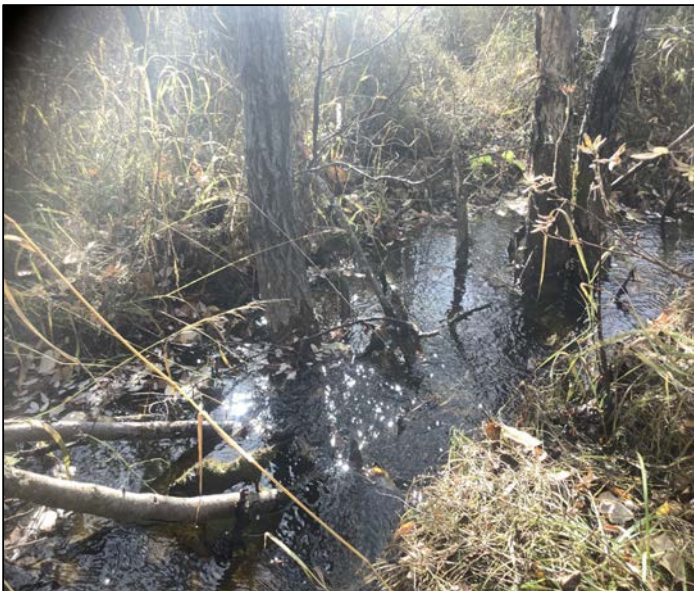
Photo 3. Section of intermittent channelization, 50 m east of winter road
