# **Mackenzie Valley Highway Project Technical Data Report—Fish and Fish Habitat**

**Government of the Northwest Territories**

**K'alo-Stantec Limited**

December 2022

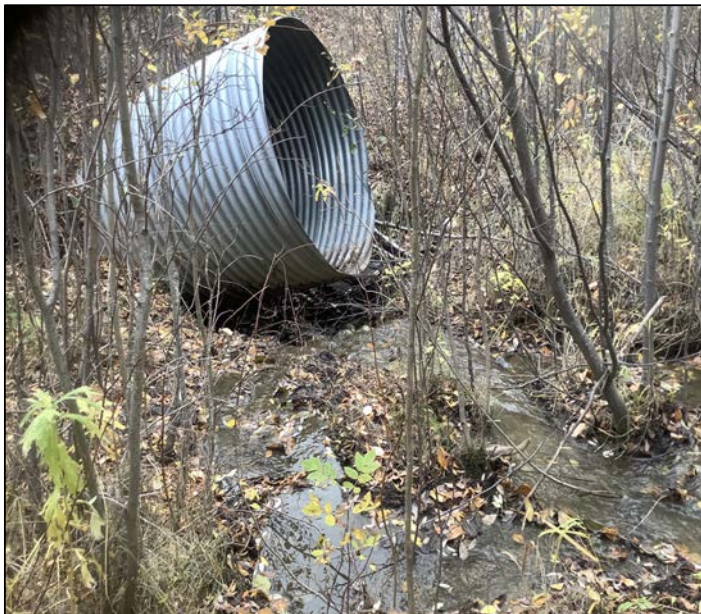
Existing culvert at this site is broken on the inlet and bank is sloughing on the outlet causing a temporary barrier to fish (see crossing WX-043 Culvert). Confluence with Mackenzie River located approximately 110 m downstream. Potential gradient barrier (30% slope) with step pools 30 m upstream of confluence. Potential velocity barrier at step pools 100 m upstream from centerline. No transect completed at 50 m upstream as stream became inaccessible in root bridge complexes for approximately 50 m. No fish were captured or observed during the fish assessment.

Photo 1. Facing right downstream bank towards inlet

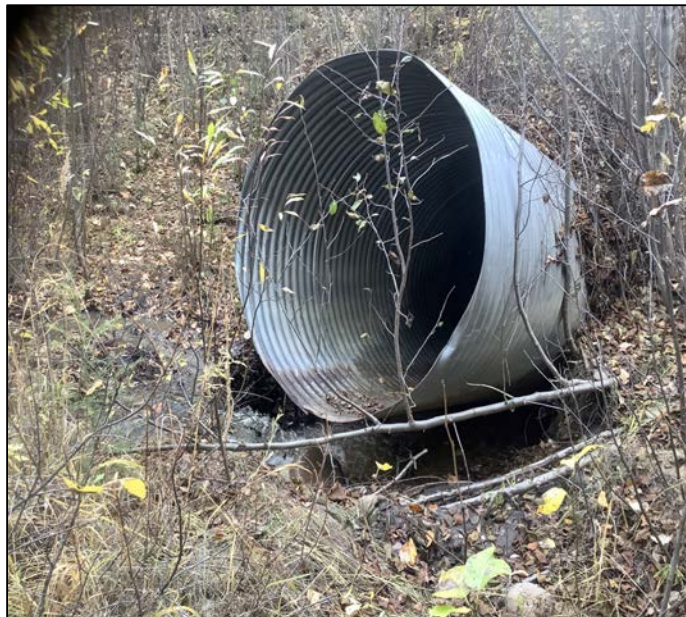
Photo 2. Facing left downstream bank towards inlet

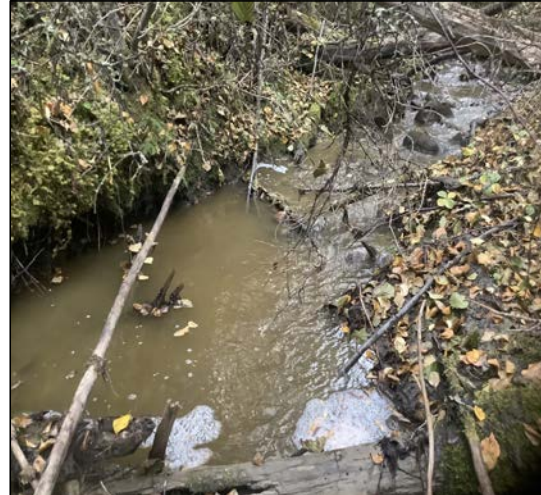
Photo 2: Facing upstream 50 m upstream of centerline.

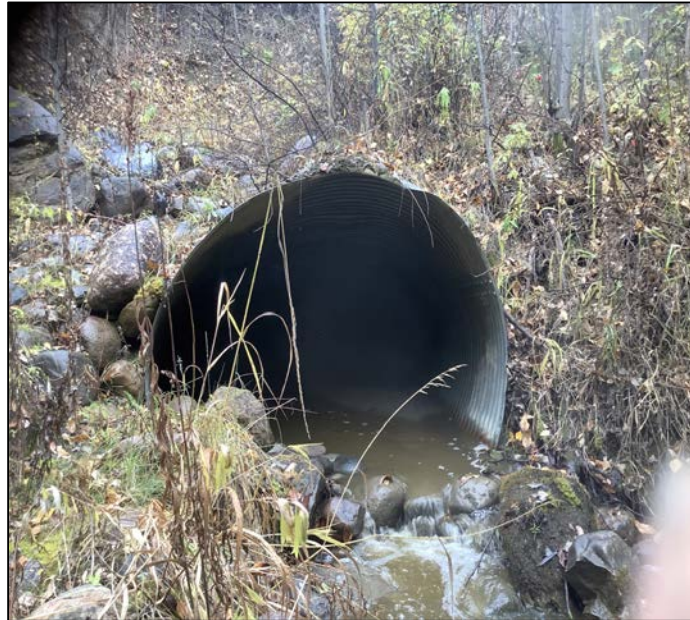
| General Comments | | | | | | |
|---|--|--|--|--|--|--|
| No fish captured or observed during fish assessment. Gradient barrier identified 50 m upstream from confluence with Mackenzie River, 24 % gradient over 20 m of stream length. Culvert collapsed under existing road, see WX-044 Culvert summary data sheet. | | | | | | |

Photo 2. Facing outlet of culvert

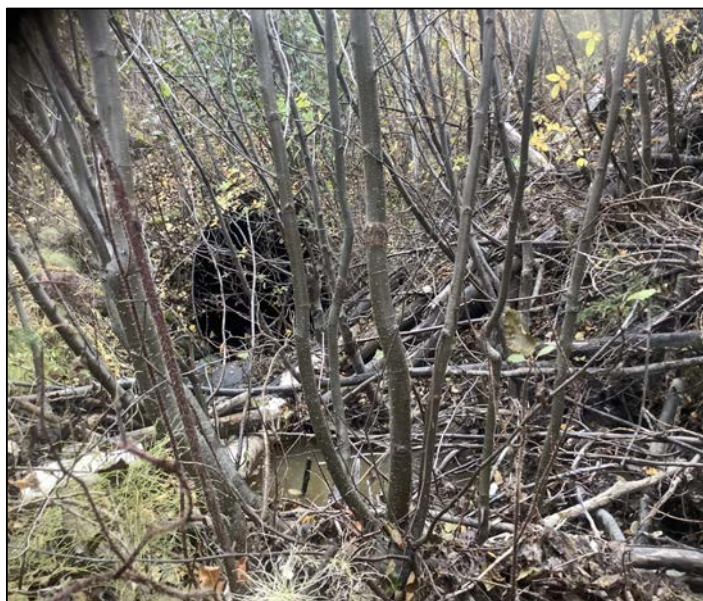
Photo 3. Facing downstream towards culvert inlet

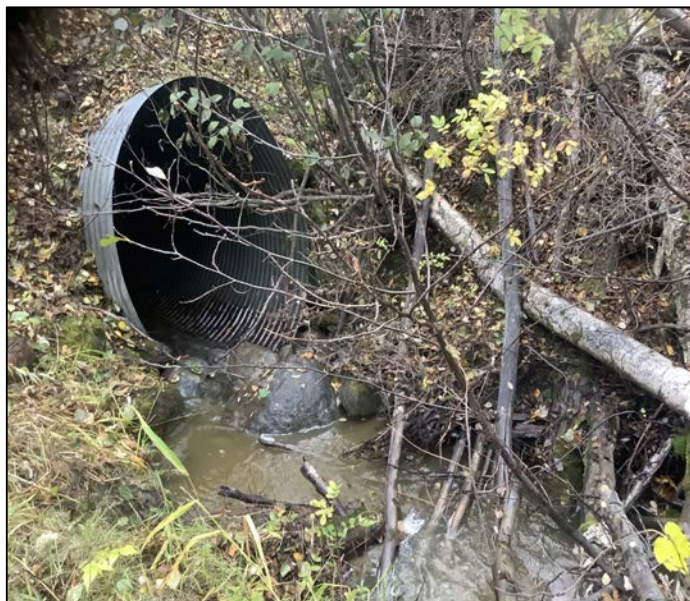
Photo 4. Facing downstream towards culvert inlet

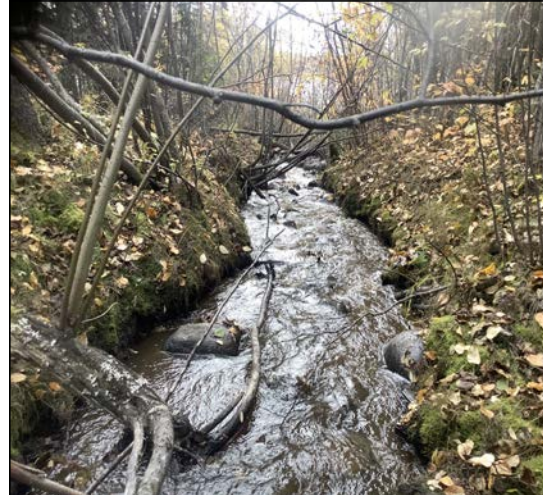
Photo 2: Facing downstream at 150 m downstream from centerline.
