# **Mackenzie Valley Highway Project Technical Data Report—Fish and Fish Habitat**

**Government of the Northwest Territories**

**K'alo-Stantec Limited**

December 2022

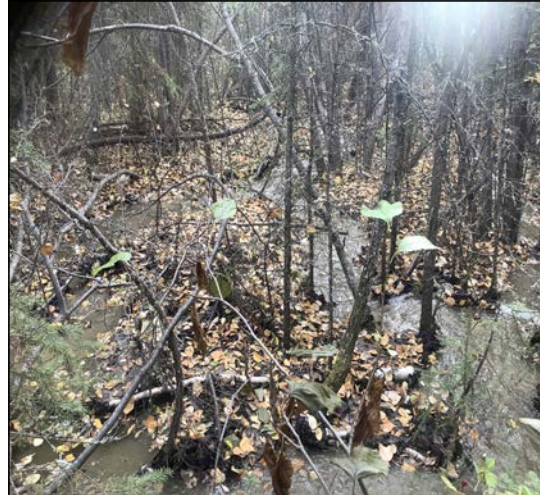
Photo 2: Facing downstream 50 m downstream of centerline.

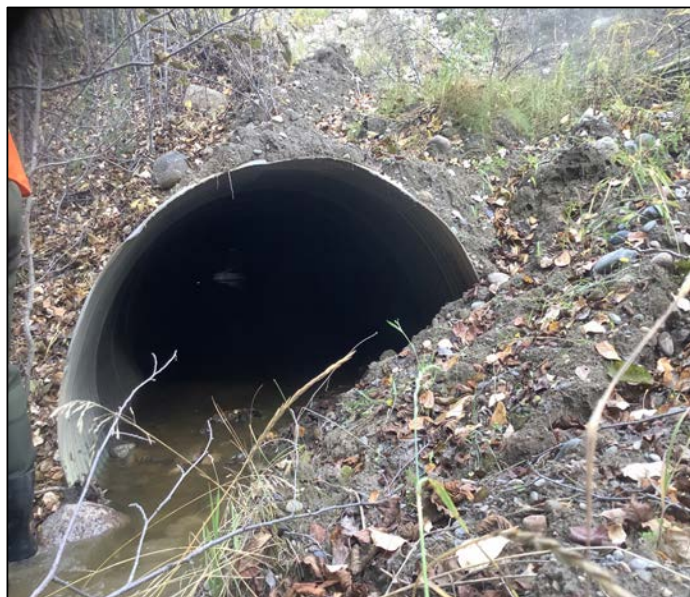
Photo 4. Culvert outlet

Culvert associated with watercourse crossed at WX-043. 1,500 mm diameter culvert. Culvert appears to be collapsed and broken, especially at inlet. Evidence of ice jams against existing winter road.

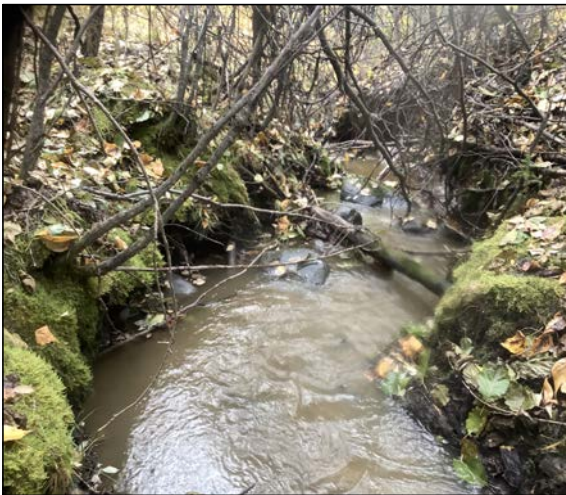
Photo 1: Facing upstream 100 m downstream from centerline.

| General Comments | | | | | | |
|---|--|--|--|--|--|--|
| No fish captured or observed during fish assessment. Gradient barrier identified 50 m upstream from confluence with Mackenzie River, 24 % gradient over 20 m of stream length. Culvert collapsed under existing road, see WX-044 Culvert summary data sheet. | | | | | | |

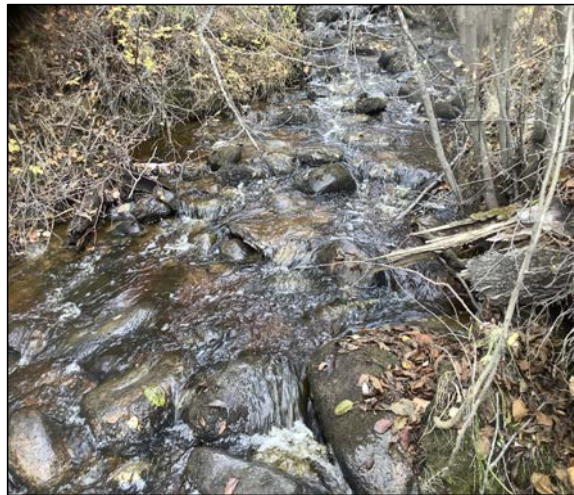
Photo 1: Facing upstream at 50 m upstream from centerline.

| Fish Sampling Data | | | | | | | | | | | |
|---|---|---|---|---|---|---|---|---|---|---|---|
| Overall poor fish habitat due to steep gradient. Two potential gradient barriers (15% and 17% slope) near confluence with Mackenzie River, approximately 200 m downstream from centerline. Large (7,000 mm diameter) culvert on Bob's Canyon Creek at existing winter road appears in good condition. Fish assessment not completed as fish presence was known. | | | | | | | | | | | |
